Supplemental Site Investigation Report

**Clegg Residence
729 Corley Road
Wolcott, Vermont 05661**

**SMS Site #: 2008-3857
Site Coordinates: 44° 33' 17.55" N, 72° 29' 80.60" W**

18 May 2009

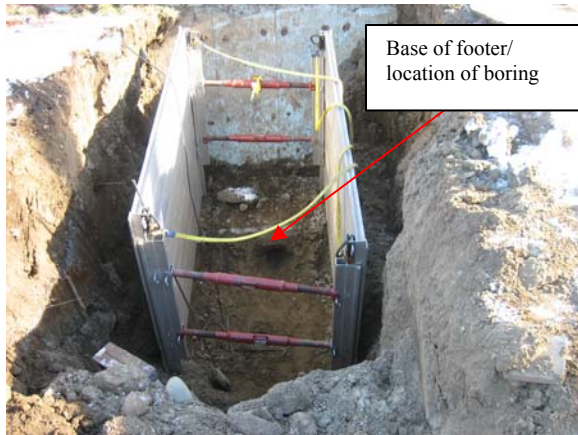
On 16 and 17 December 2008, *R.E.A.* provided oversight during the excavation of three test pits (EA-1, EA-2 and EA-3) adjacent to the residence's foundation wall to the depth of the footer. Excavation Area #1 (EA-1) was installed midway along to the west foundation wall of the residence approximately 15 feet south and west of the petroleum release located on the north side of the inside of the residence. The excavation extended to a depth of approximately eight feet below ground surface (bgs) and approximately one foot below the concrete foundation footer. The top of foundation footer was located at approximately seven feet bgs. and extended approximately two feet out from the outside edge of the foundation wall, which was believed to be 12 inches thick. The perimeter drain, constructed of four-inch perforated PVC pipe was located on top of the footer adjacent to the foundation wall. No petroleum odors were noted during excavation activities. A temporary vapor monitoring point was installed horizontally beneath the footer/ basement floor approximately six feet in from the edge of the foundation footer (three feet in from the outside edge of the exterior footer) using a KVA soil gas system. PID readings of ambient air measured thru the un-purged line from beneath footer/basement floor were 0.0 ppm. PID readings of soil samples collected from soils in the vicinity of the footer and beneath the concrete floor were all 0.0 ppm. Soils in the excavation consisted primarily of fine silty sands and gravel.

Photograph #3 - Installation of Excavation Area-1 (EA-1) - view to east

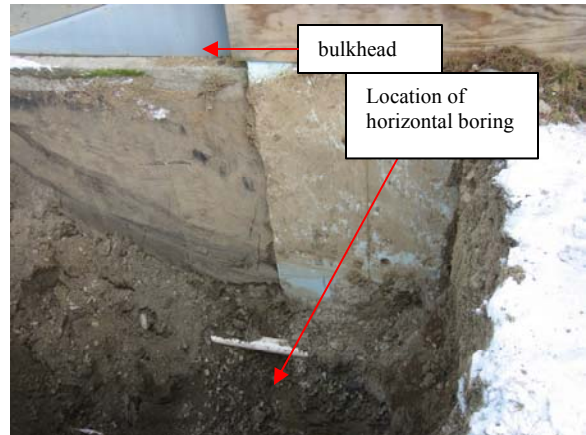
EA-2 was installed at the northwest corner of the residence, adjacent to the bulkhead access to the basement on the western side of the west foundation wall in the general vicinity of the main release area. EA-2 was extended to a depth of approximately eight feet bgs and approximately one foot below the foundation footer. The sewer drain line exiting the residence in a western direction was encountered approximately six inches bgs. A portion of this line (approximately 5.0' long) was

removed and subsequently replaced prior to backfilling in order to accommodate for excavation activities. The perimeter drain line was located in gravel bedding at approximately six feet bgs. PID readings of ambient air from within the four-inch perforated PVC perimeter pipe were 0.0 ppm. During excavation, petroleum odors were noted in soils/gravel located in the vicinity of the bottom of the foundation footer/foundation wall interface. A temporary vapor monitoring point was installed horizontally just under the foundation footer using a KVA soil gas system. The horizontal boring extended to approximately two feet in from the outside edge of the foundation wall, which was believed to be 12 inches thick. PID readings of ambient air from beneath footer/basement floor were 1.3 ppm. PID readings of soil samples collected in the vicinity of the footer and beneath the concrete floor at a depth of approximately six feet bgs. ranged from 0.0 to 53.8 ppm. Soils in the excavation area consisted primarily of medium brown sand with some cobbles. Soils within the impacted area at the base of the footer consisted of gravel bedding related to the perimeter drain. Due to the presence of elevated PID readings on soils collected in the vicinity of the bottom of the footer/foundation wall interface, one vertical vapor point (VP-1) was installed, by hand, at the bottom of the excavation. The vapor point was constructed of 0.01 slotted schedule 40, 1-inch PVC and extended to a depth of approximately eight feet bgs. Soils around the vapor point were backfilled to grade. Following installation, PID readings of ambient air from within the installed point were 0.0 ppm. During the investigation of EA-2, the basement bulk head was accessed and heavy petroleum odors were noted within the bulkhead area. No petroleum odors were noted inside the basement; however, PID concentrations from within the western expansion joint crack ranged from 3.5 to 114 ppm.

Photograph #4 - Installation of Excavation Area-2 (EA-2) - view to east

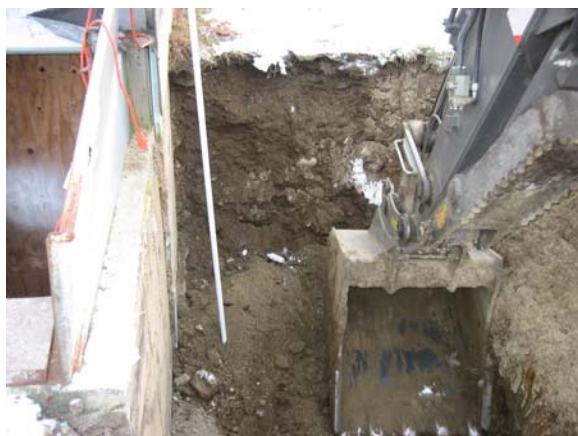
Photograph #5 - Installation of Vapor Point (VP-1) in EA-2 - view to south

3. An additional soil vapor extraction point should be installed in the vicinity of the bulkhead. This new point along with the existing vapor extraction point should be linked to a small, temporary Soil Vapor Extraction (SVE) system to assist in remediating potential sub-slab/sub-surface vapors that are present in this area and to stimulate natural sub-surface bioremediation processes.

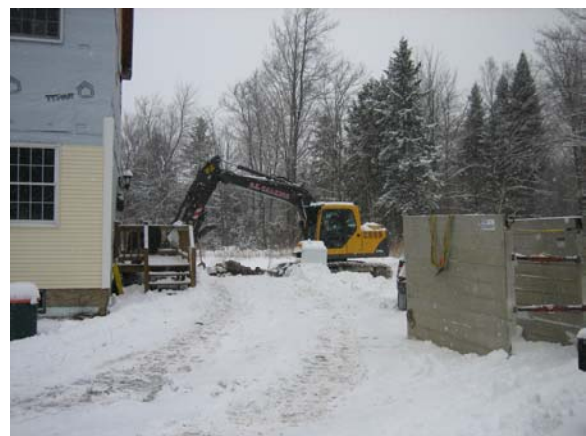
EA-3 was installed adjacent to the east side of the east foundation wall in the general vicinity north of the porch and generally between the release area and the onsite supply well. EA-3 was extended to a depth of approximately seven feet bgs at the base of the foundation footer. Installation of a temporary vapor monitoring point was attempted using a KVA, however; groundwater was present at the bottom of the excavation at the base of the footer and inhibited the ability to auger beneath the concrete footer/floor. Soils in the excavation consisted primarily of medium brown sand, gravel with some cobble and fine silty sands near the base of the footer. A PID was used to screen soils samples in the vicinity of the footer, all readings were 0.0 ppm. **R.E.A.'s** field personnel screened soil samples from each excavation for the possible presence of volatile organic compounds (VOCs) using a portable PID. The PID was calibrated with an isobutylene standard gas to a benzene reference on the day of the excavation. Soil samples were placed in resealable plastic bags, which were then sealed and agitated. Headspace in the bag was then screened for the possible presence of VOCs with the PID.

Photograph #6 - Installation of EA-3 - view to north

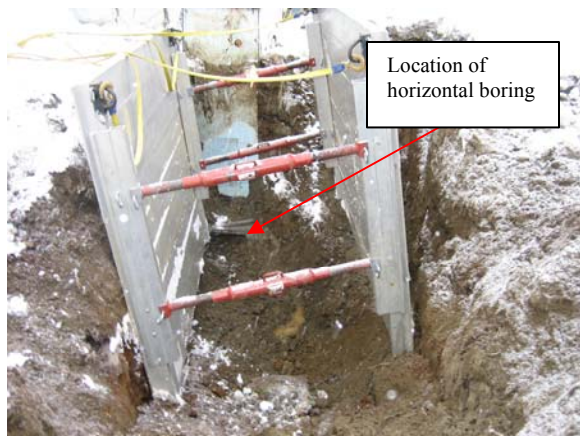
Photograph #7 - Installation of EA-3 - view to west

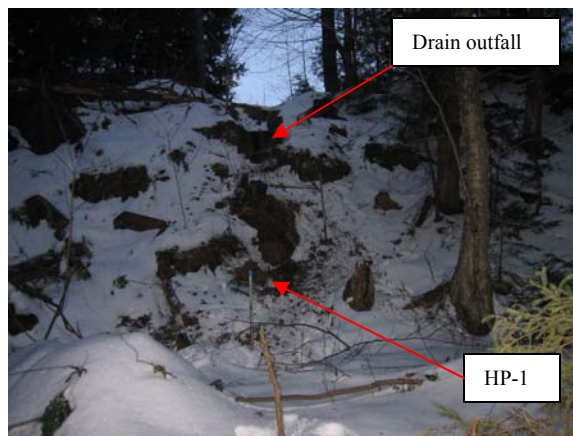
On 17 December 2008, *R.E.A.* advanced 10 hand augured soils borings into the steep bank in the general down gradient vicinity of the foundation drain outfall. Soil samples were screened for the possible presence of VOCs using a PID. PID readings for each soil sample were all 0.0 ppm. A summary of the PID readings obtained from the hand points are included on **Table 3**, Appendix A. One hand point (HP-1) was installed at the base of the slope in a downgradient location approximately ten feet from the foundation drain outfall. A stream bank assessment of the unnamed tributary of the Lamoille River was conducted to identify possible seasonal seeps, stains, odors, etc. that were not observable during the August sampling event. No observable signs of petroleum contamination or petroleum odors were noted during the December inspection. Information and evidence obtained during the initial spill response indicated the presence of petroleum contaminated soils at the base of the foundation drain outfall during spill response activities in May 2008. The removal of approximately 0.5 cubic yards of PCS combined with the process of natural attenuation has greatly reduced the threat of petroleum contamination in this area. Biodegradation and dilution/dispersion may have aided in the attenuation of petroleum compounds in soils below the drain outfall. Three drums of petroleum contaminated soils that were removed from the area beneath the foundation drain outfall and related to work during the initial spill response, along with one drum of petroleum contaminated granulated activated vapor phase carbon used during the initial spill response, were transported off-site for disposal by Environmental Products and Services (EP&S) of Burlington, VT.

- Photo-ionization detector (PID) readings on soil samples collected from the vicinity of the foundation drain outfall were all 0.0 ppmv. Information and evidence obtained during the initial spill response in May of 2008, indicated the presence of petroleum contaminated soils at the base of the foundation drain outfall. The removal of approximately 0.6 cubic yards of PCS combined with the process of natural attenuation has greatly reduced the threat of petroleum contamination to soil and groundwater in this area. Biodegradation and dilution/dispersion may have aided in the attenuation of petroleum compounds in soils below the drain outfall.

Photograph #8 - Screening of soils at foundation drain outfall - view to east

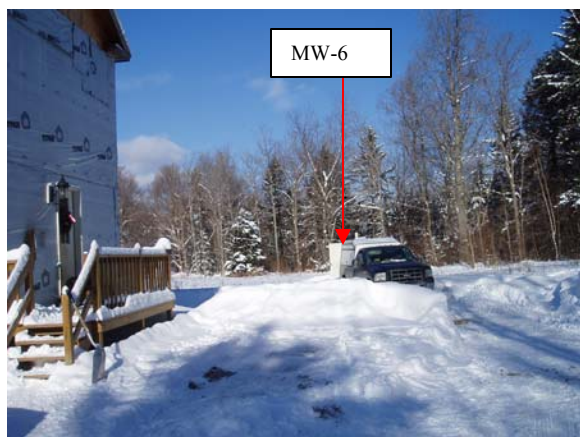
The soils consisted primarily of medium to light brown sand and unsorted gravel. All of the soil borings were completed to rock refusal, which was encountered between 13 and 15 feet below ground surface (bgs). Groundwater was encountered between eight and eleven feet bgs. Photo-ionization

Photograph #9 - Installation of MW-6 - view to north

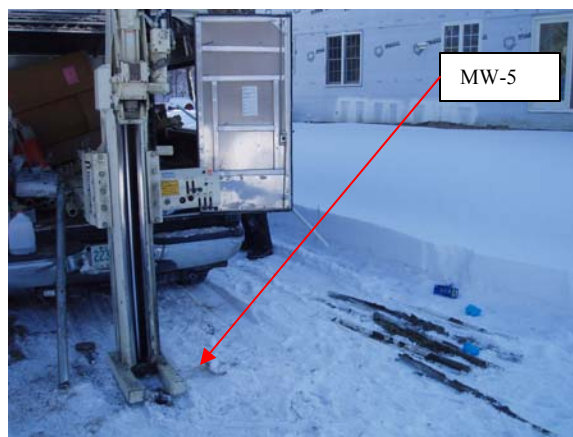
Photograph #10 - Installation of MW-5 - view to southeast

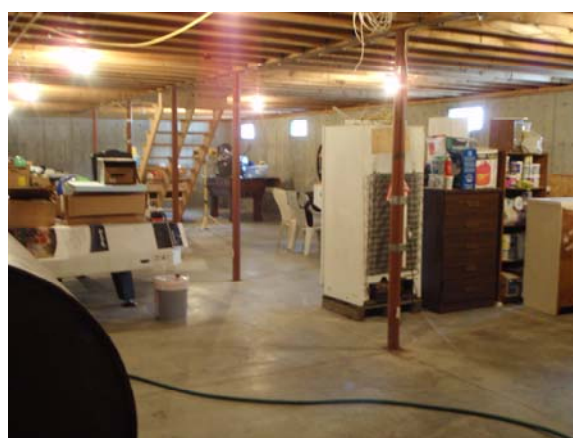
readings of indoor air and air from within the expansion joint in the basement have shown a trend in decline since the interior cleaning and application of Biosolve™. Periodic screenings of the eastern floor expansion joint throughout the life of the project, both preceding and following the cleaning of the floor, have indicated no elevated levels of VOCs (0.0 ppm). A 6% Biosolve™/water solution was mixed and generously applied with a mop to the western side of the concrete basement floor (spill area) and expansion joint crack. This same mixture was applied to the eastern side of the concrete floor with an industrial sprayer. All loose basement contents were placed on top of the larger furniture items and all items that came in contact with the floor were wiped down with the solution. The Biosolve™/water solution was used on the concrete blocks holding up the furnace and hot water heater and was also applied approximately 12-18” up the side of the basement walls. Loose basement and first floor contents and surfaces were also wiped down with Buckeye Blue™ all purpose, water based cleaner. Wood floors located on the first floor and the basement stairs were cleaned with Murphy’s Oil™. Rugs and furniture upholstery located throughout the upstairs of the residence were shampoo washed. Vaportek VaporSHARK™ industrial odor control system was utilized on the first floor of the residence to neutralize impregnated petroleum odors.

On 17 March 2009, Based on field observations and findings during follow up indoor air screenings *R.E.A.* personnel administered a second application of the Biosolve™ solution directly to the expansion joint crack. PID readings of a ambient air and air within the expansion joint seemed to rise slightly immediately following the second application but overall the general trend shows a decrease of PID readings and petroleum vapors throughout all locations inside the Clegg residence. A detailed table with results and locations of the indoor air screening is located on **Table 7** in Appendix A.

Photograph #12 - View of basement after cleaning and Biosolve application to crack - view to east

2. The basement should be evaluated for potential vapor intrusion. All potential vapor pathways should be identified and sealed to reduce the risk of vapor intrusion from residual petroleum contamination located beneath the slab. Specifically, the expansion joint crack on the west side of the basement floor should be sealed with a VOC compliant self leveling professional grade expansion joint sealant.

4. Site conditions should be evaluated with respect to petroleum odors. Bi-Monthly indoor odor inspections should be performed with specific focus on first floor ambient air, basement air and air in the vicinity of the western expansion joint and any other potential vapor pathways. During the bi-monthly odor checks, ambient air at these locations should be checked for the possible presence of petroleum odors and screened for the possible presence of VOC's with a PID.
